REPAIR, EVALUATION, MAINTENANCE, AND  
REHABILITATION RESEARCH PROGRAM

TECHNICAL REPORT REMR-OM-08

REMR MANAGEMENT SYSTEMS—NAVIGATION STRUCTURES

MANAGEMENT SYSTEM FOR  
MITER LOCK GATES

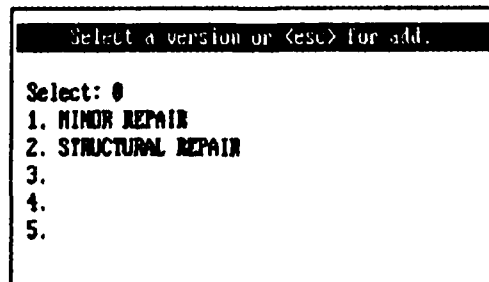
50. Figure A23 illustrates a typical display of M&R solutions. Each solution displays the Old Combined CI (from MITER evaluation), the New Combined CI, First Cost (\$), and Annual Cost (\$), if these have been previously computed.
